# Geoenvironmental Appraisal

## Land at Field Lane, Thorpe Willoughby For JSR Farms Limited

Report no: 2123/1

Date: May 2015

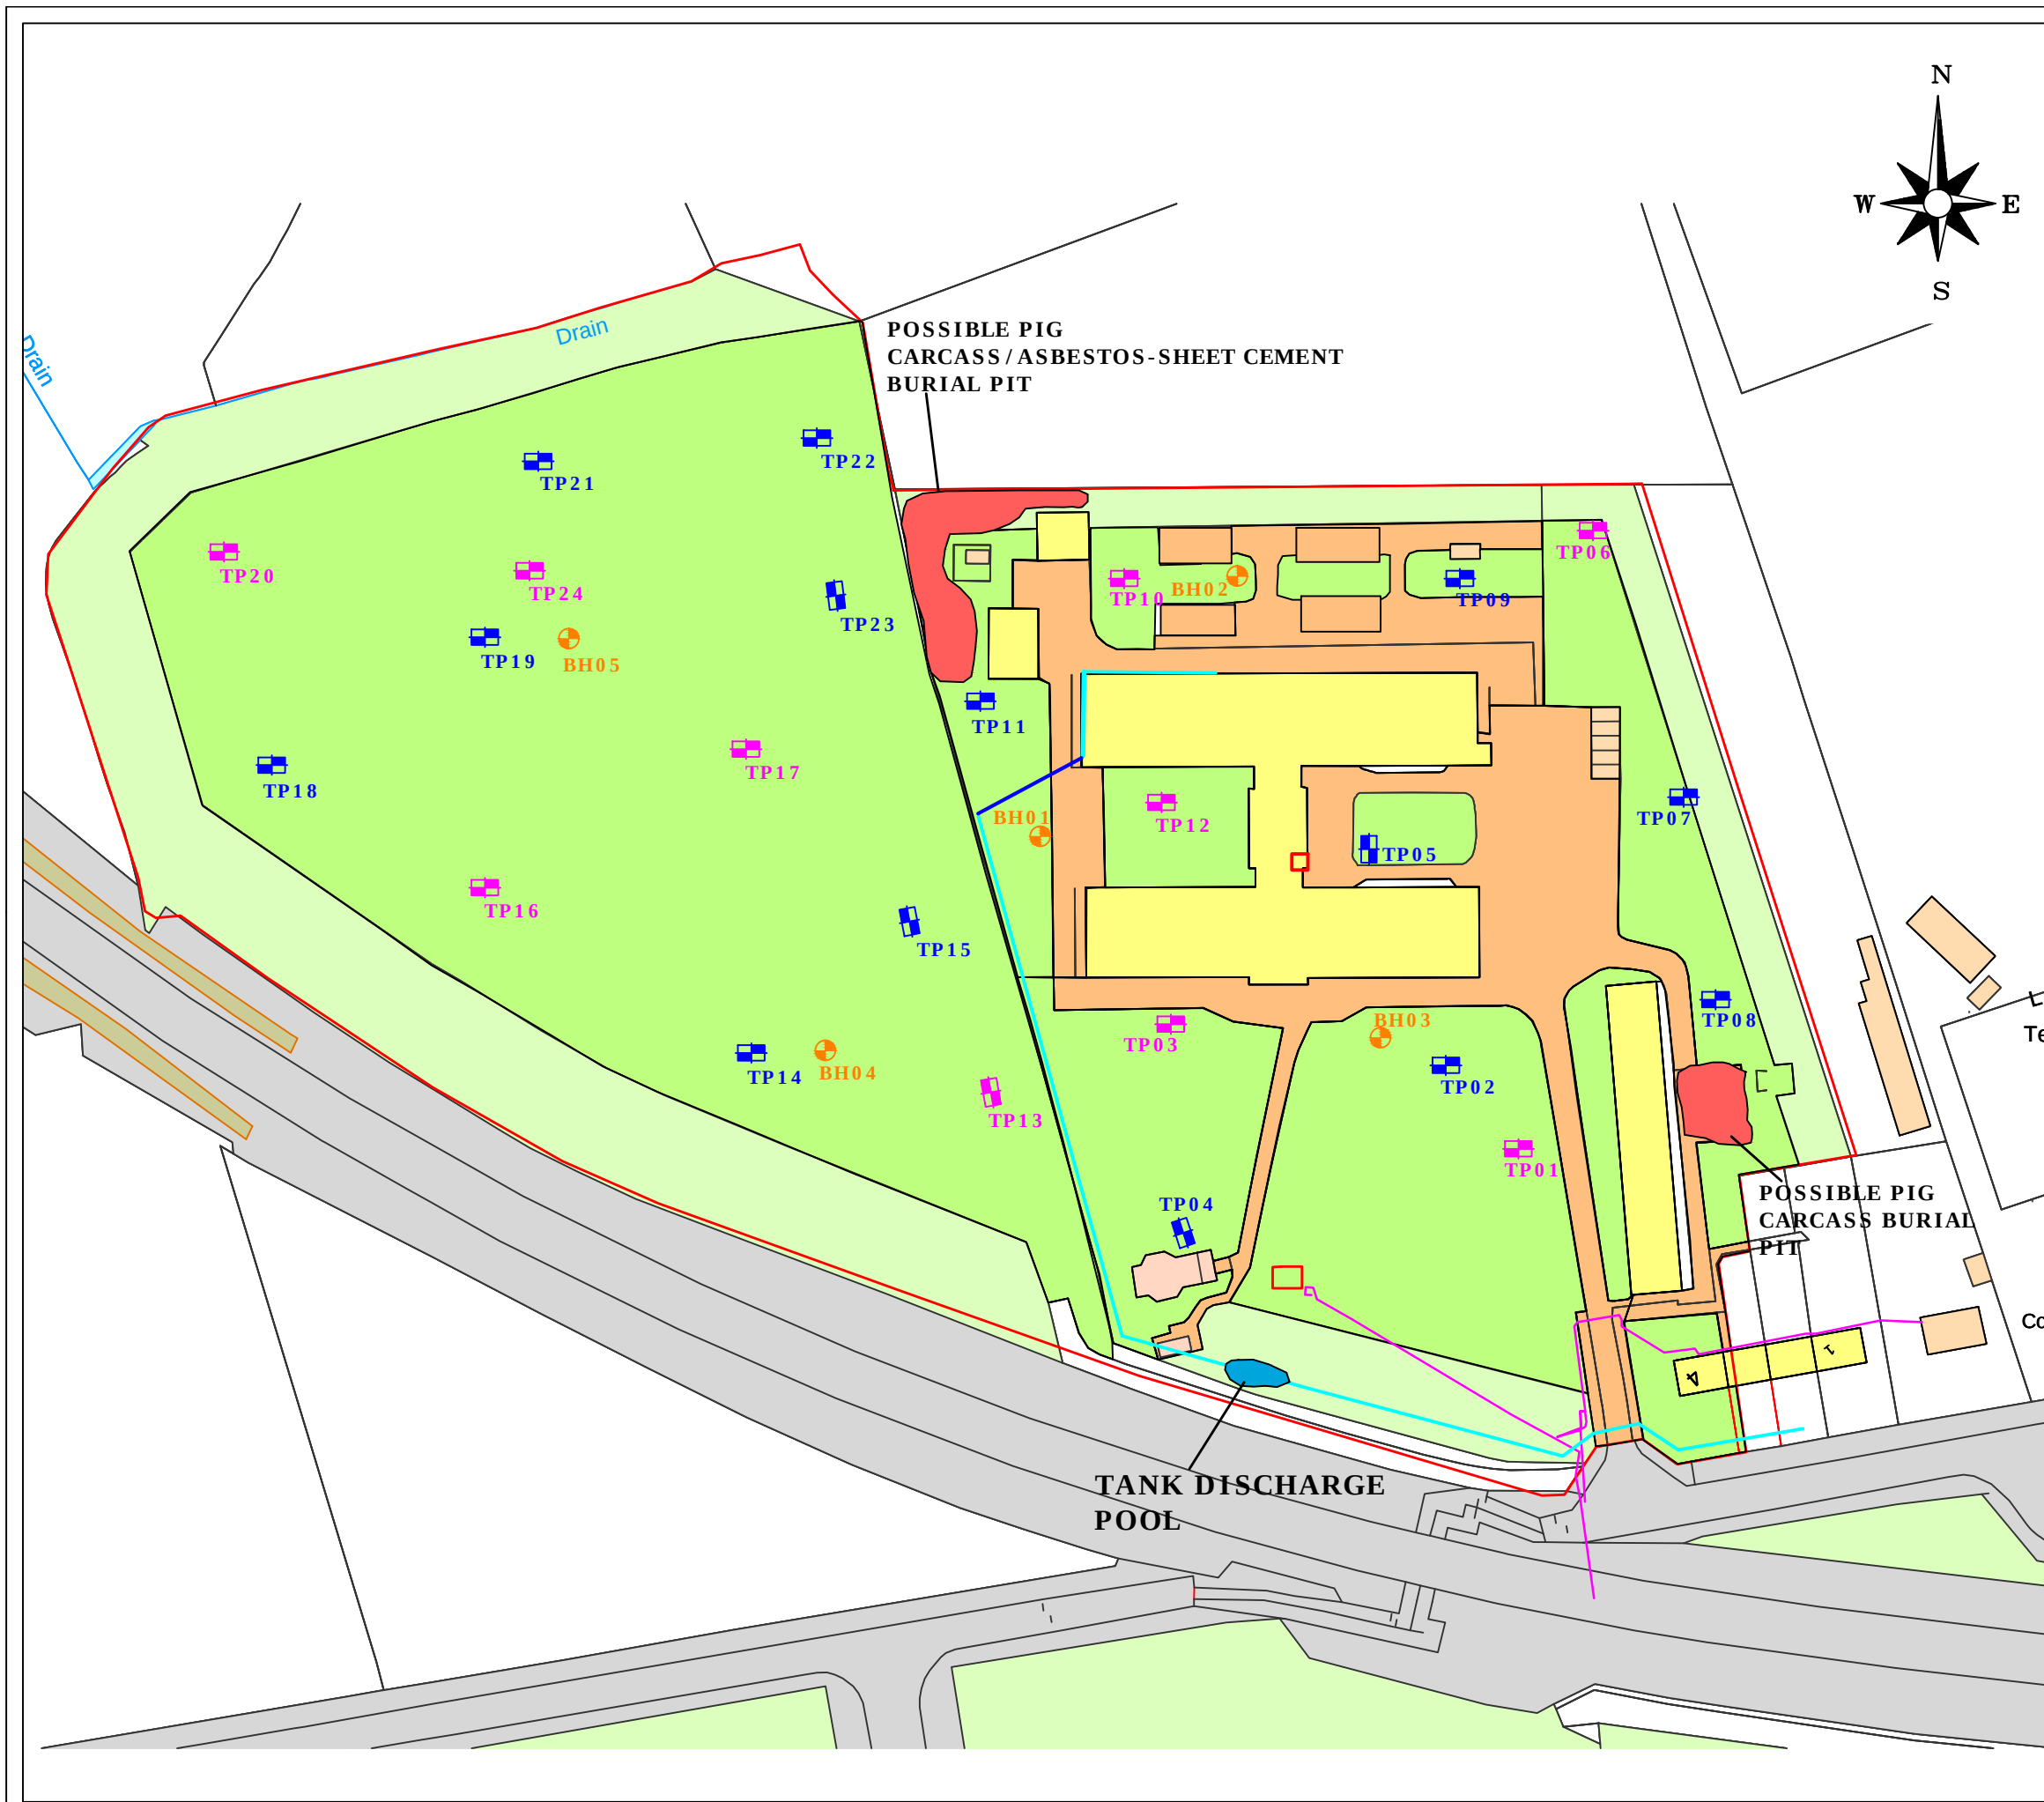
- BOREHOLE LOCATION
- TRIAL PIT LOCATION
- SOAKAWAY TEST LOCATION
- APPROXIMATE SITE BOUNDARY
- UNDERGROUND ELECTRIC
- UNDERGROUND BT
- OVERHEAD BT
- APPROXIMATE / INFERRED SEWER LOCATIONS
